Cate School Corp. Bank Stabilization and Fish Passage Restoration Project

Fish Barrier Removal Project
and
Bank Stabilization Project
Carpinteria Creek
Carpinteria, CA 93013

Project Summary:

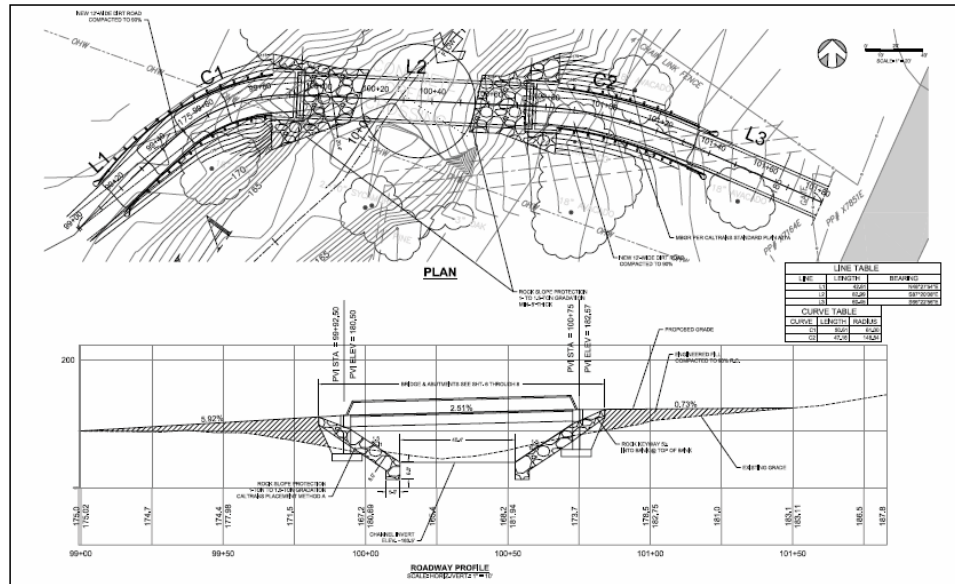
Design above shows plan and profile views of new clear span bridge to be installed.

Designs call for the removal of the crossing, regrading of the creek and replacement with a prefabricated bridge. Because of scouring that has eroded the edges of the crossing, the structure is on the verge of failure and presents a hazard to vehicle passage as well as to downstream property during flood flows. The crossing provides the landowner's only available access to the other half of its property.

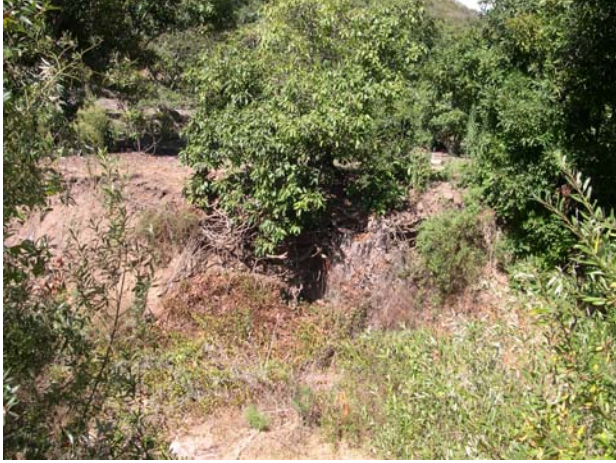
Cate School – Typical Area for Bank Stabilization

Project consists of the protection of steep vertical banks by implementing biotechnical bank stabilization measures such as root wad structures and willow trenching. Project will act as a demonstration project to other property owners in the Carpinteria Valley as well as around the South Coast of Santa Barbara County. Project would decrease the amount of unnatural sediment flowing into the creek as well as increase the habitat quality along this portion of the creek.

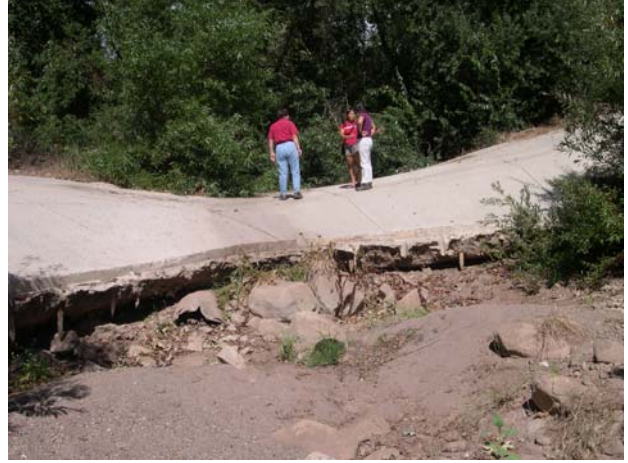
Low flow road crossing at Cate School

The concrete crossing is 33 feet wide and approximately 76 feet across the creek. The Steelhead Assessment and Recovery report noted that undercutting of the crossing has created a four-foot vertical jump. According to the study, the crossing creates an “extremely high to impassable” barrier for upstream migration, and is important for recovery of the Carpinteria Creek’s steelhead population. The removal of this barrier to fish passage on Carpinteria Creek will allow steelhead to migrate approximately 1,267 feet through habitat rated moderate by the report to the next barrier BR_CA_6.
