Raya Property Fish Passage Restoration Project

Carpinteria, California

Fish Barrier Removal Project
Gobernador Creek
Carpinteria, CA 93013

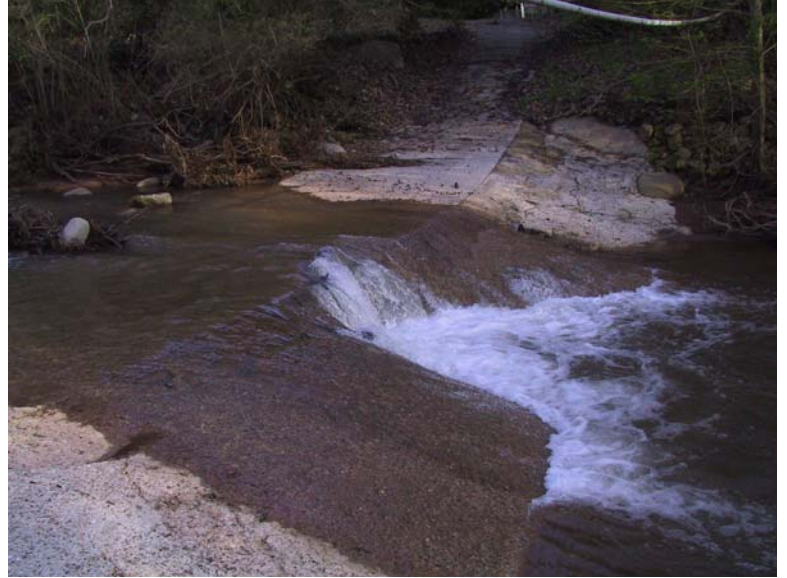
Downstream barrier, BR_CA_GR_3

The Steelhead Assessment study found a total of 15 anthropogenic barriers in the Carpinteria Creek Watershed. Of those, ten barriers were rated as moderate to impassable to fish migration. This project would remove two barriers, BR_CA_GR_3 and BR_CA_GR_4 found along Gobernador Creek. The low flow instream crossings, which contain box culverts, were rated as 0.8 (High) and 0.9 (Extremely High to Impassable) respectively by the study. The downstream barrier BR_CA_GR_3 is a concrete crossing which spans the stream channel in a gradual U-shape from bank top to bank top. A concrete box culvert measuring 60 inches wide and 26 inches tall at the downstream end extends 136 inches under the center of the crossing. A debris grate composed of 2-inch diameter metal bars surrounds the inlet of the culvert where flows drop 23 inches from the upstream substrate down into the culvert bottom. The pool below the crossing extends into the culvert and created a depth of 8 inches throughout. The upstream barrier BR_CA_GR_4 is also a concrete stream. The crossing spans the entire stream channel in a gradual U-shape from bank top to bank top. A concrete box culvert measuring 60 inches wide and 28 inches tall at the downstream end extends 146 inches under the center of the crossing. A debris grate composed of 3-inch diameter metal bars covers the inlet with a flat, parallel configuration and 6-inch spacing between the bars. Flows pass through the grate and down a steep slope at the inlet of the culvert and drop 40 inches to the culvert bottom. Unlike the crossing downstream, the culvert bottom extends downstream of the culvert 34 inches and forms a small ledge. At low flows, water drops 3 inches off this ledge into a pool downstream with a maximum depth of 3 feet.

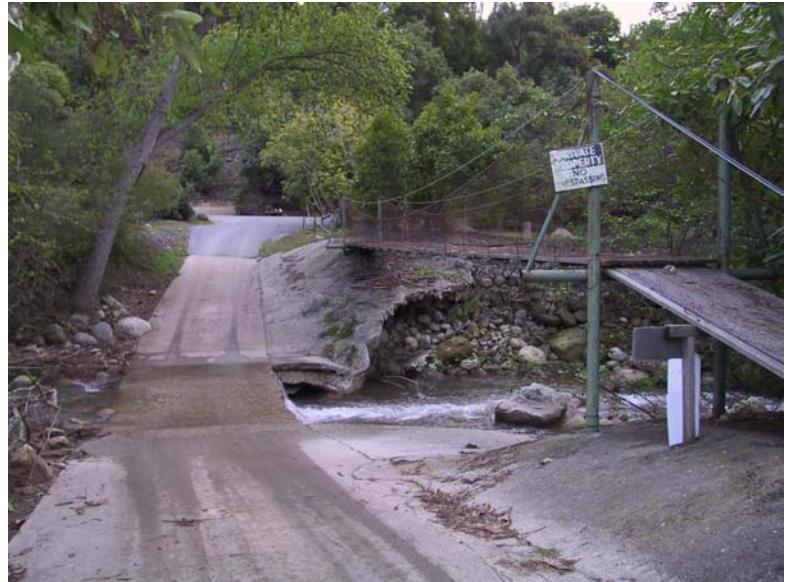
Upstream barrier, BR_CA_GR_4
