THE LIFE OF CARPINTERIA CREEK IS IN THE FLOW
By Tim Robinson

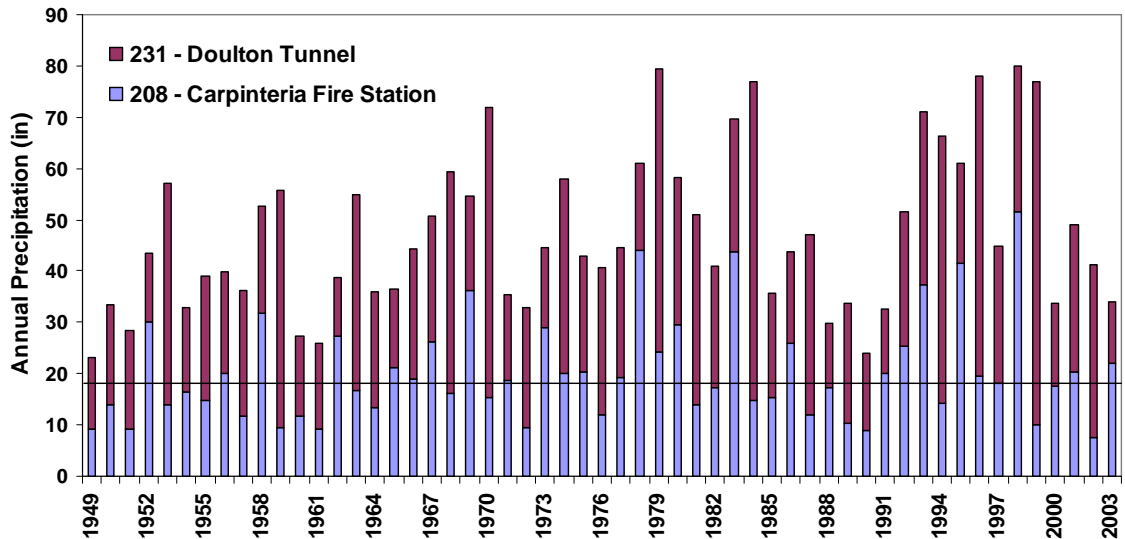
Figure 1: Rainfall patterns on the coastal plain (208-Carpinteria Fire Station) and at mid elevation (231-Doulton Tunnel at 1775 ft) sites, demonstrating orographic effects; a) average monthly precipitation showing the seasonality, and b) total annual precipitation for the same sites during common years of record (1949-2003). The line at 17.5 inches represents the median value at the Carpinteria Fire station, 20 inches is the average.

Carpinteria Creek Watershed is just under 15.4 mi² (40 km²) long, and is one of the larger watersheds on the South Coast. Our Mediterranean climate, characterized by warm dry summers and cool rainy winters, brings highly seasonal rainfall that can vary significantly from year to year, with a long term average of 20 inches. The mountains help to catch the clouds (orographic effect) and can approximately double the annual precipitation in the upper watershed (Figure 1). Noteworthy months of record precipitation since monitoring began in 1949 were January 1969 (18.3 inches), January 1995 (21.4 inches), and February 1998 (23.5 inches); all were accompanied by heavy flooding events.

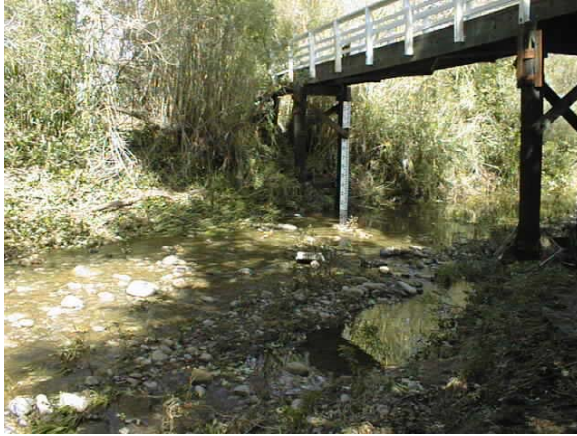
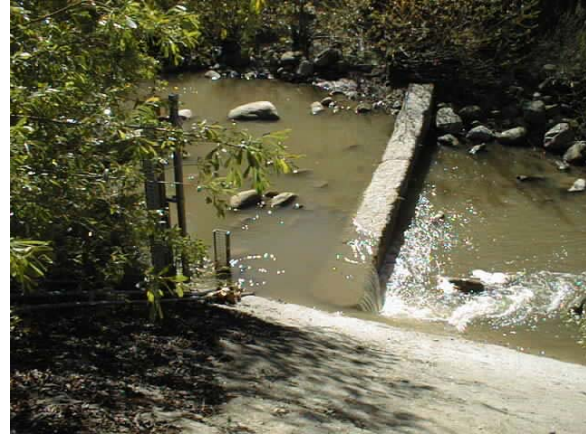
Figure 2: Two of the four gauging locations on Carpinteria Creek, 8th Street Footbridge and the USGS station near Hwy 192 Bridge. Both have staff gauges at the deepest point of the channel at a determined cross-section.

There are four stream gauging stations that measure flow on Carpinteria Creek (Figure 2). They are operated by the US Geological Survey, U.C. Santa Barbara (SBC-LTER), and the County of Santa Barbara. The USGS facility located near the Hwy 192 Bridge has the longest recorded discharge record (1941 to the present) and is a low-profile constructed weir with a bubbler and telemetry system for online/real-time data access. The County shares that infrastructure for their flood management studies. Gauging stations in the upper watershed and at the outlet are maintained by SBC-LTER
