# Widdoes Property Fish Passage Restoration Project

## Carpinteria, California

Fish Barrier Removal Project  
Gobernador Creek  
Carpinteria, CA 93013

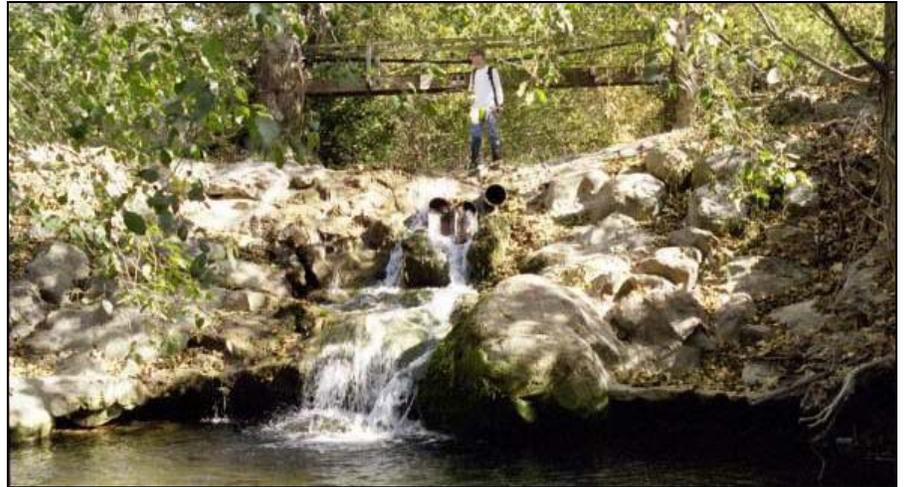
View of the fish passage barrier from Stoecker, et al, *Steelhead Assessment and Recovery Opportunities in Southern Santa Barbara County, California*, June 2002

The Widdoes crossing spans the stream channel in a shallow U-shape and consists of boulder and concrete riprap, measuring about 15 feet from the surface of the crossing to the bottom of the pool. The Steelhead Assessment and Recovery Project noted the significant undercutting of the crossing has created a 10-foot vertical jump and 15-foot horizontal jump, impassable during steelhead migration. According to the study, BR\_CA\_GR\_5 crossing creates an exceptionally difficult barrier for upstream migration, and is extremely important for recovery of the Carpinteria Creek steelhead population. The removal of this last major barrier to fish passage on this tributary will allow steelhead to migrate up to 5.5 miles to habitat rated extremely high by the Stoecker/CCP report.

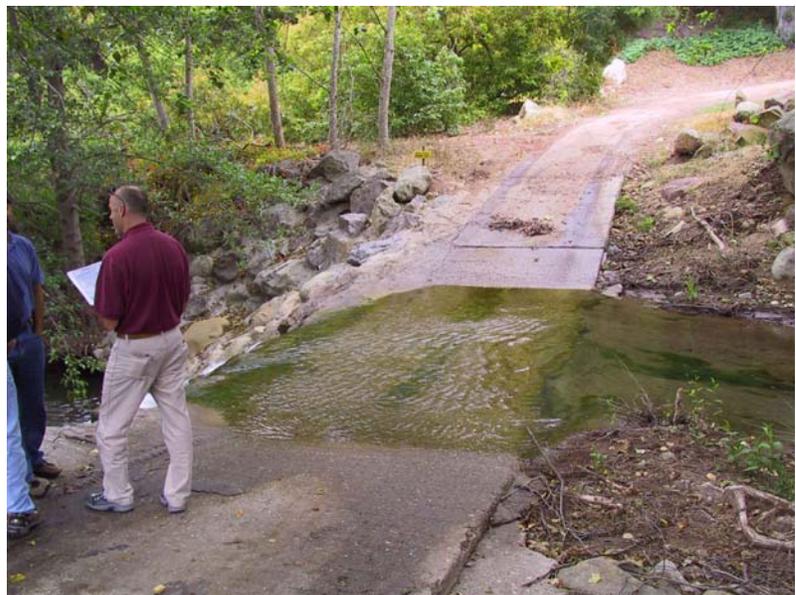
The low flow crossing as seen from the road

The Carpinteria Creek watershed is located in coastal Santa Barbara County, about 10 miles southeast of the City of Santa Barbara and 16 miles northwest of the City of Ventura. The proposed site is located on Gobernador Creek on the Widdoes property and can be characterized as a low flow crossing with three culverts.

Preliminary design concepts call for the removal of the crossing and its replacement with a prefabricated bridge. The landowner has already considered removal of the crossing and replacement with a bridge. The landowners representative has attended a CCWC meeting and expressed interest in removing the crossing and installing a bridge. Because of scouring that has undercut the substrate support for the crossing; the structure is on the verge of failure and presents a hazard to vehicle passage and to downstream property during flood flows. The crossing provides the landowner's only available access to the other half of its property and as a consequence must be replaced with some structure if removed.
