SECTION 3: CLIMATE, HYDROLOGY AND WATER USE

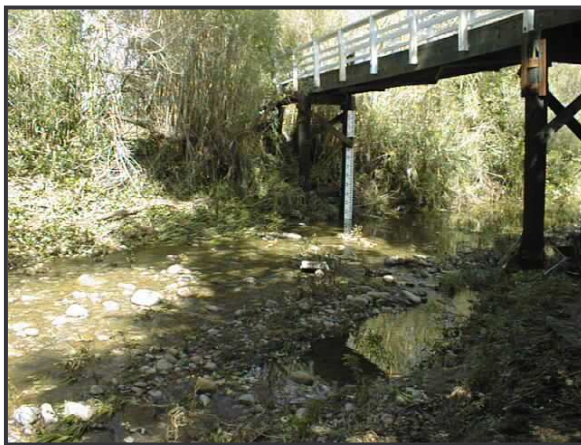
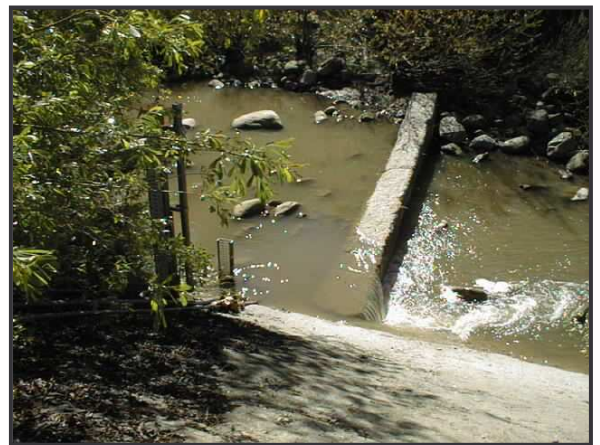
Figure 3.3: Two of the four gauging locations on Carpinteria Creek, 8th Street Footbridge and the USGS station near Hwy 192 Bridge. Both have staff gauges at the deepest point of the channel at a determined cross-section.

There are five stream gauging stations that measure flow on Carpinteria Creek (Table 3.3), one operated by the USGS near Hwy 192 Bridge, a parallel gauge at the same location operated by the County of Santa Barbara (County), and three by U.C. Santa Barbara (SBC-LTER). SBC-LTER installed gauges are at the outlet just above the tidal influence and one on each of the main tributaries in the upper watershed (Figure 3.2, and Figure 3.3). The USGS facility has the longest recorded discharge record (1941 to the present) and is a low-profile constructed weir with a bubbler and telemetry system for online/real-time data access (US Geological Survey, 2004). The County gauge at that same site has a pressure transducer and telemetry system that facilitates data collection for flood analysis. SBC-LTER gauging stations consist of a pressure transducer fixed to the channel bottom and a staff gauge on the side of the channel for visual observation of stage.

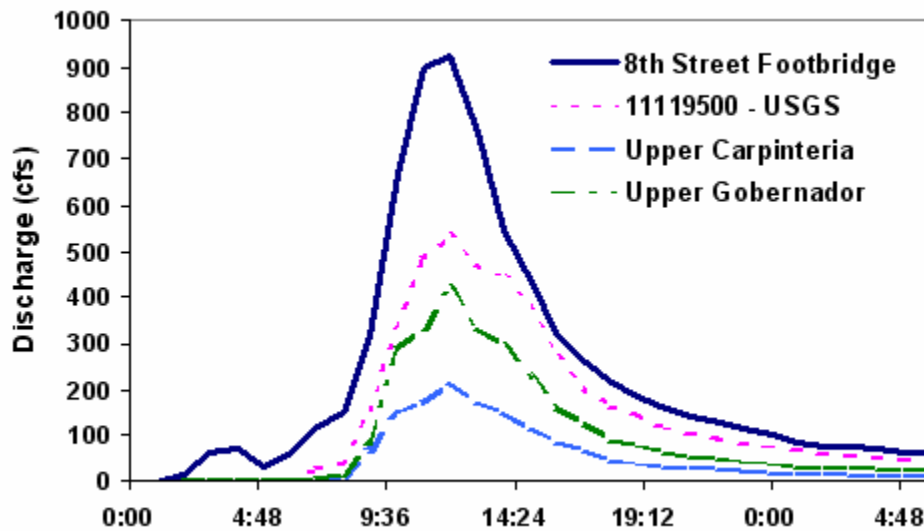
Figure 3.6: Nested stream hydrographs during the March 15, 2003 storm where over five inches of rainfall fell on the basin.

Stream hydrographs are curves showing the rise and fall of the stream over time. In a multi-land use watershed such as Carpinteria Creek, it is common to have a bimodal storm hydrograph (two peaks), the first peak coming from the urban/impervious surface rapid flush and the second and larger peak, from the upper reaches of the watershed when full basin flow occurs. The lag time between the two peaks varies depending on the preceding soil moisture conditions (Beighley et al., 2004). Figure 3.6 shows nested hydrographs for the four gauging stations on Carpinteria Creek during the largest storm of WY 2003. The first small peak on the outlet hydrograph (8th Street Footbridge) is the urban flush followed by the full basin flow peak several hours later.

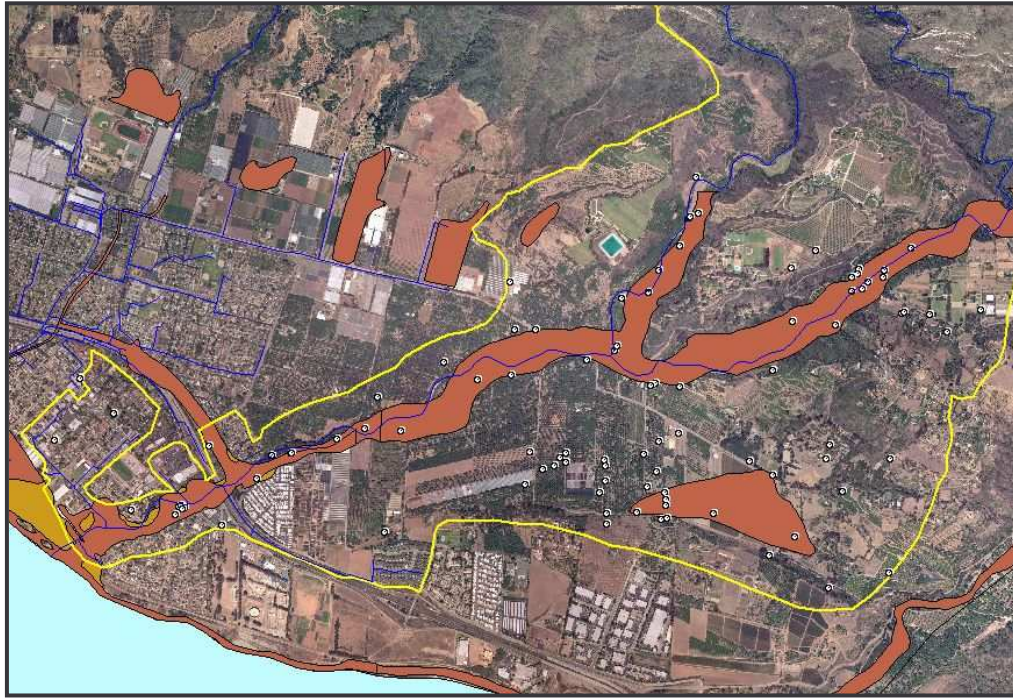
Figure 3.7: FEMA Flood Map showing the 100-year (brown) and 500-year floodplain (light brown) within or near the Carpinteria Creek Watershed. Also depicted are wells. The small circular dots indicate location of private wells.

There are over 90 private wells in the Carpinteria Creek Watershed (Figure 3.7). Some are inactive or abandoned and most are tapping shallow unconfined aquifers for agricultural use (CVWD Well Inventory Database, 2004). Smillie is the only one of the five CVWD operated wells located in the watershed, near the confluence of Upper Carpinteria and Gobernador creeks.
